**NBSIR 73-263**

# **Fire Endurance Tests of Unprotected Wood-Floor Constructions for Single-Family Residences**

**July 1973**

**Final Report**

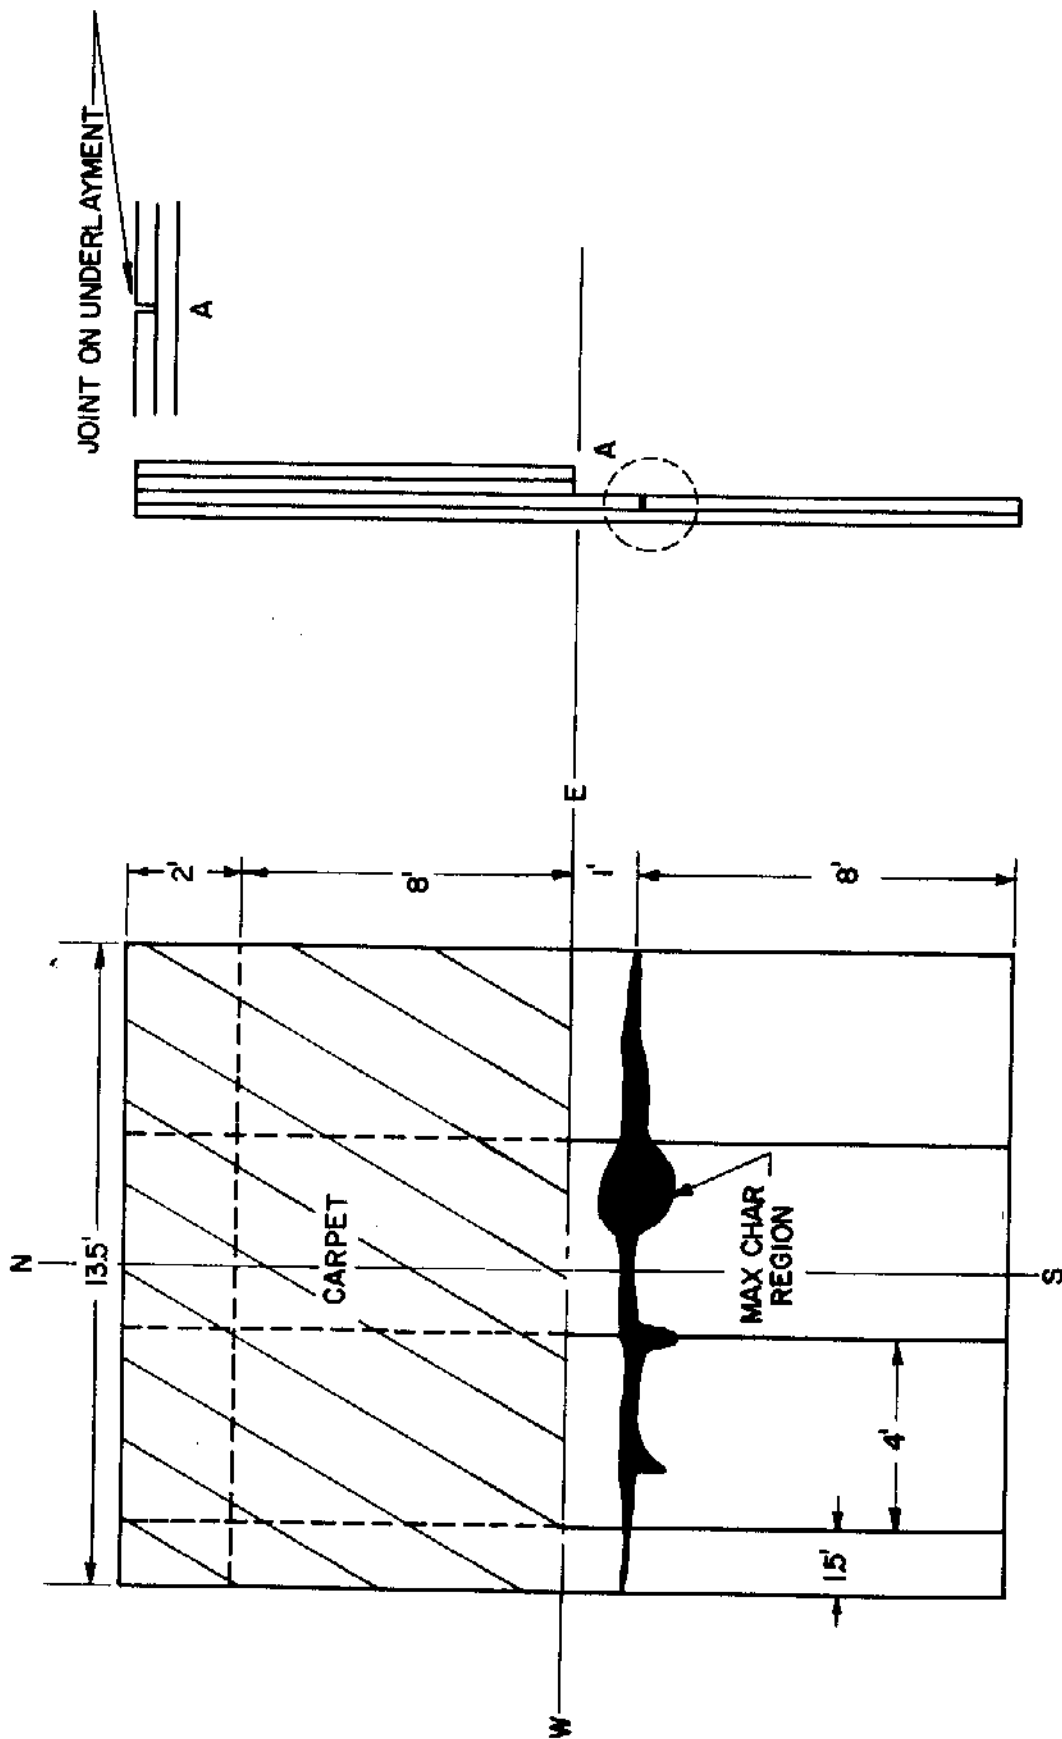
FIGURE 10. Char Region on Unexposed Surface after Test #L-1

Flame penetration near the center at the joint between the two sheets of plywood in the upper layer of the "bare" floor was observed at 13 min:30 sec. The location where flaming occurred and the associated charred region is shown in figure 10. There was also a load failure, as evidenced by the inability to maintain hydraulic pressure at 11 min:38 sec.

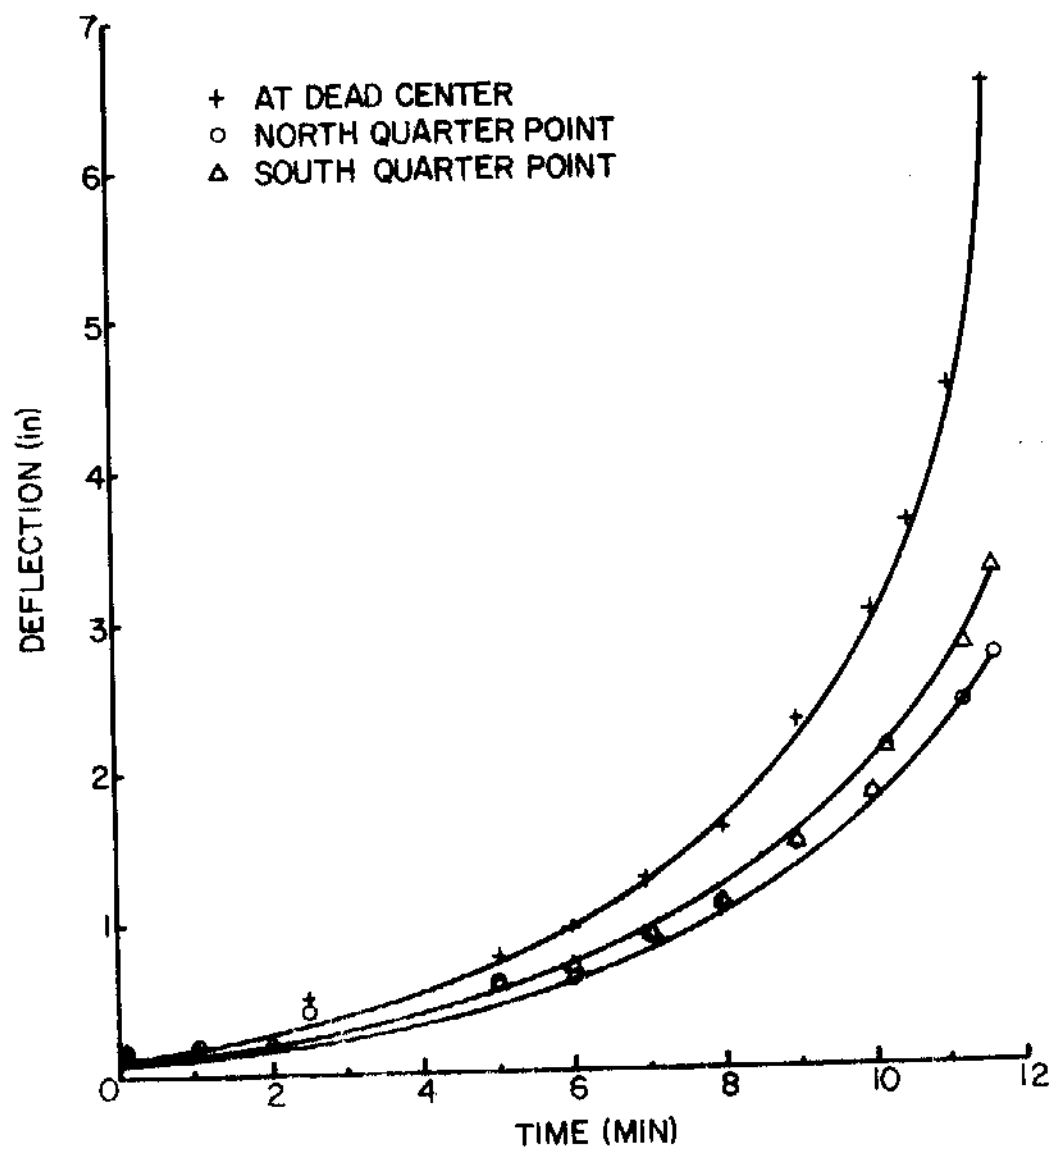
FIGURE 13. Deflection Measurements Test #L-1

The deflection increased steadily to 6.5 in. at 11 min:38 sec when the load could not be maintained as shown in figure 13. Deflections are tabulated in Table 3, Appendix I.

In the small scale tests (#S-4, -6 and -8), it was obvious that the carpeting delayed the time of "flame through" and temperature failure by 8 to 12 minutes. In the large scale test (Test #L-1), the carpet itself did not add any strength to the floor as evidenced by the slight difference in the deflections between the floor sections with or without carpet (see figure 13).

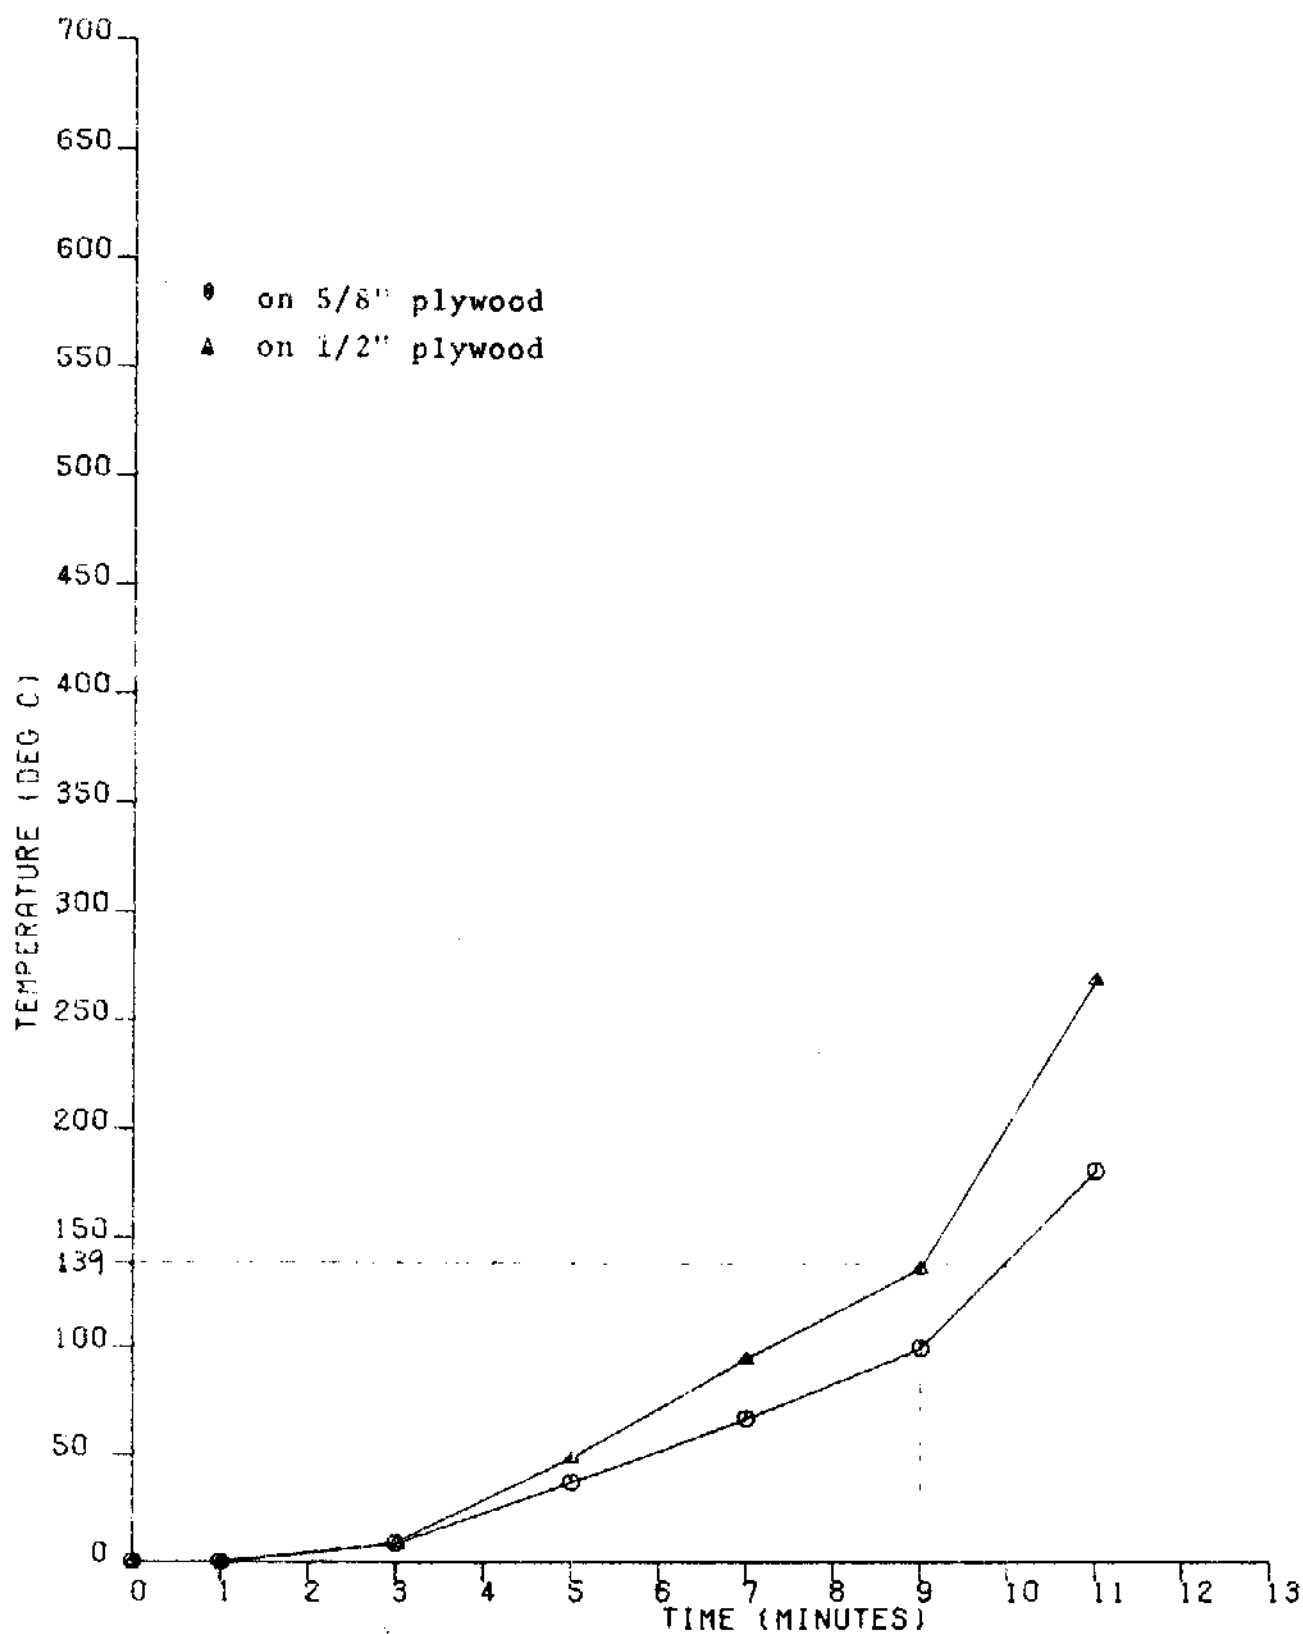
FIGURE 14. Average Temperature Rises for Test #L-2

Figure 14 illustrates average temperature rises on the unexposed surface. Temperature failure occurred at 9 min. for the 1/2 in. plywood floor and 10 min. for the 5/8 in. plywood floor.

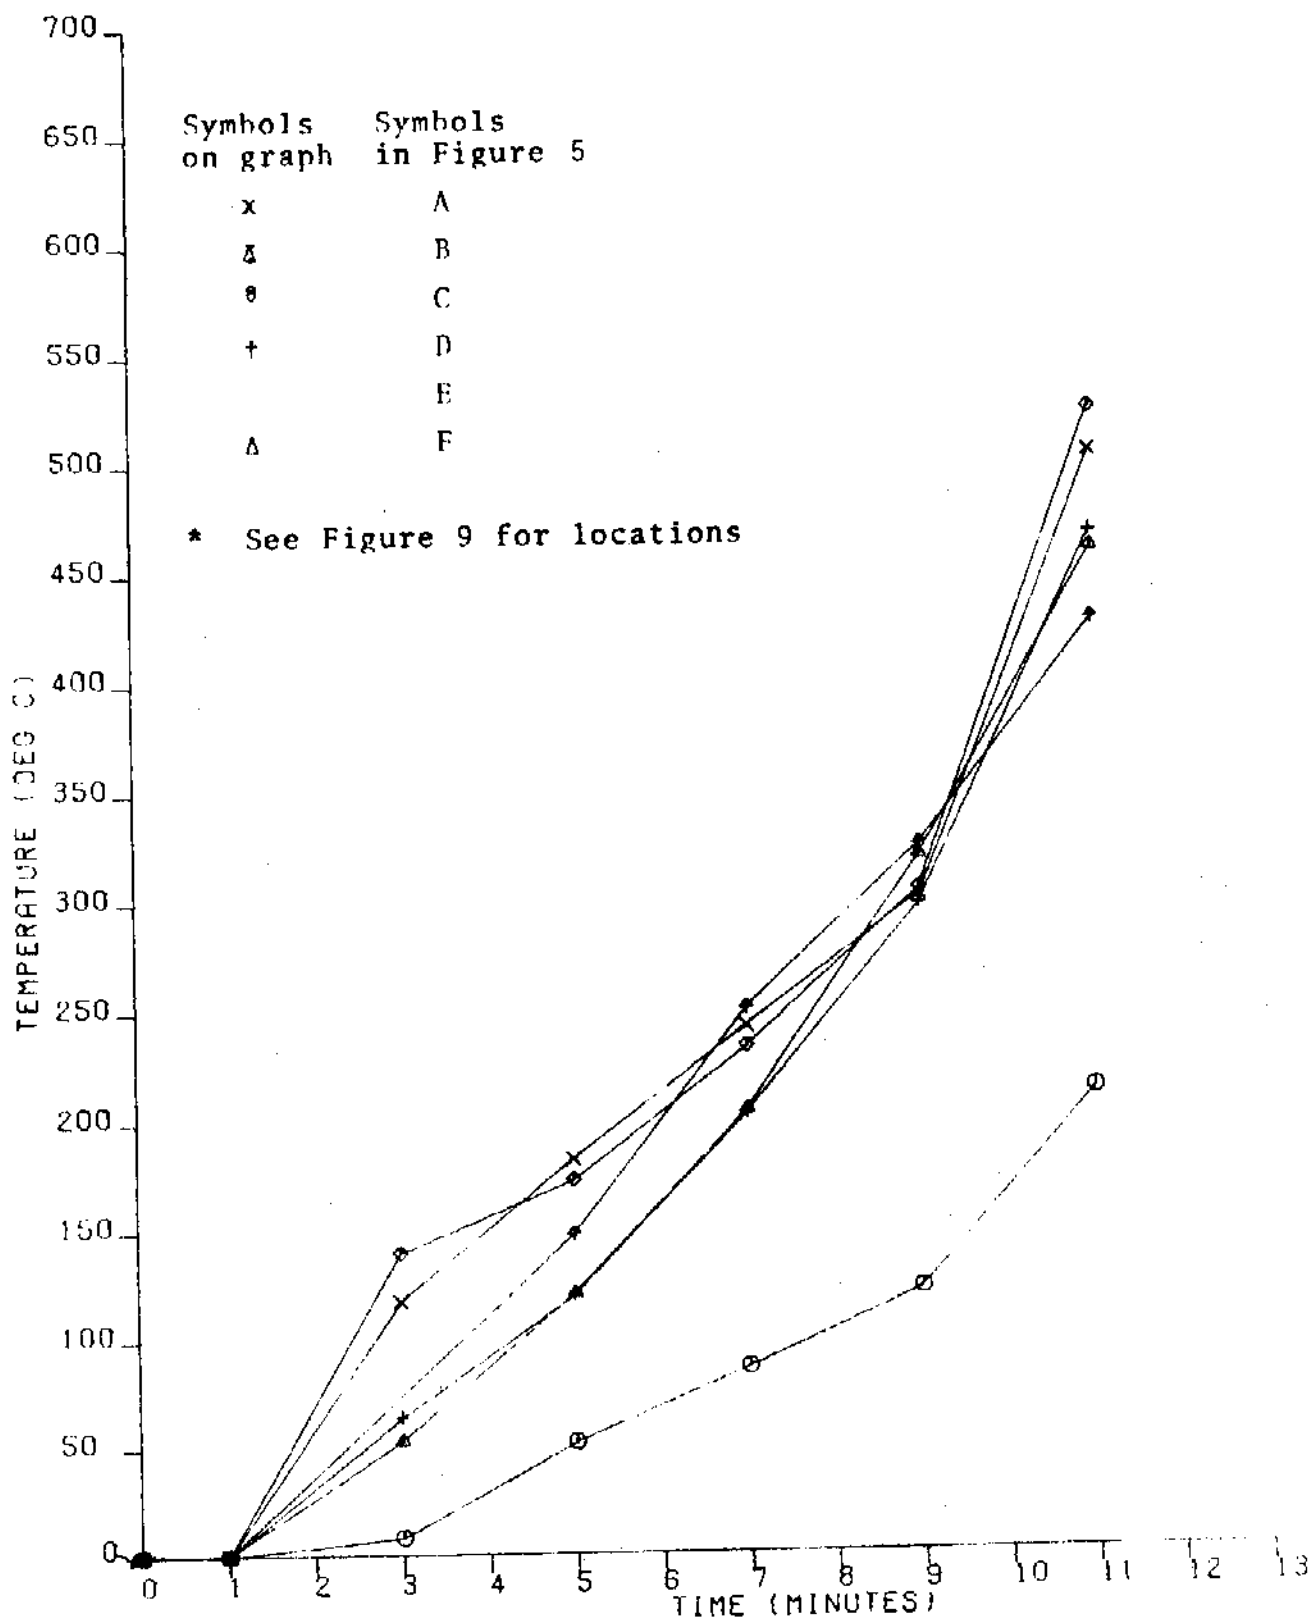
FIGURE 15. Temperature Rises of Special Thermocouples For Test #L-2

Figure 15 is the temperature history of six specially arranged thermocouples (see figure 5). The slow rise in temperature of thermocouple C illustrates the effectiveness of the blocking in protecting the joint.

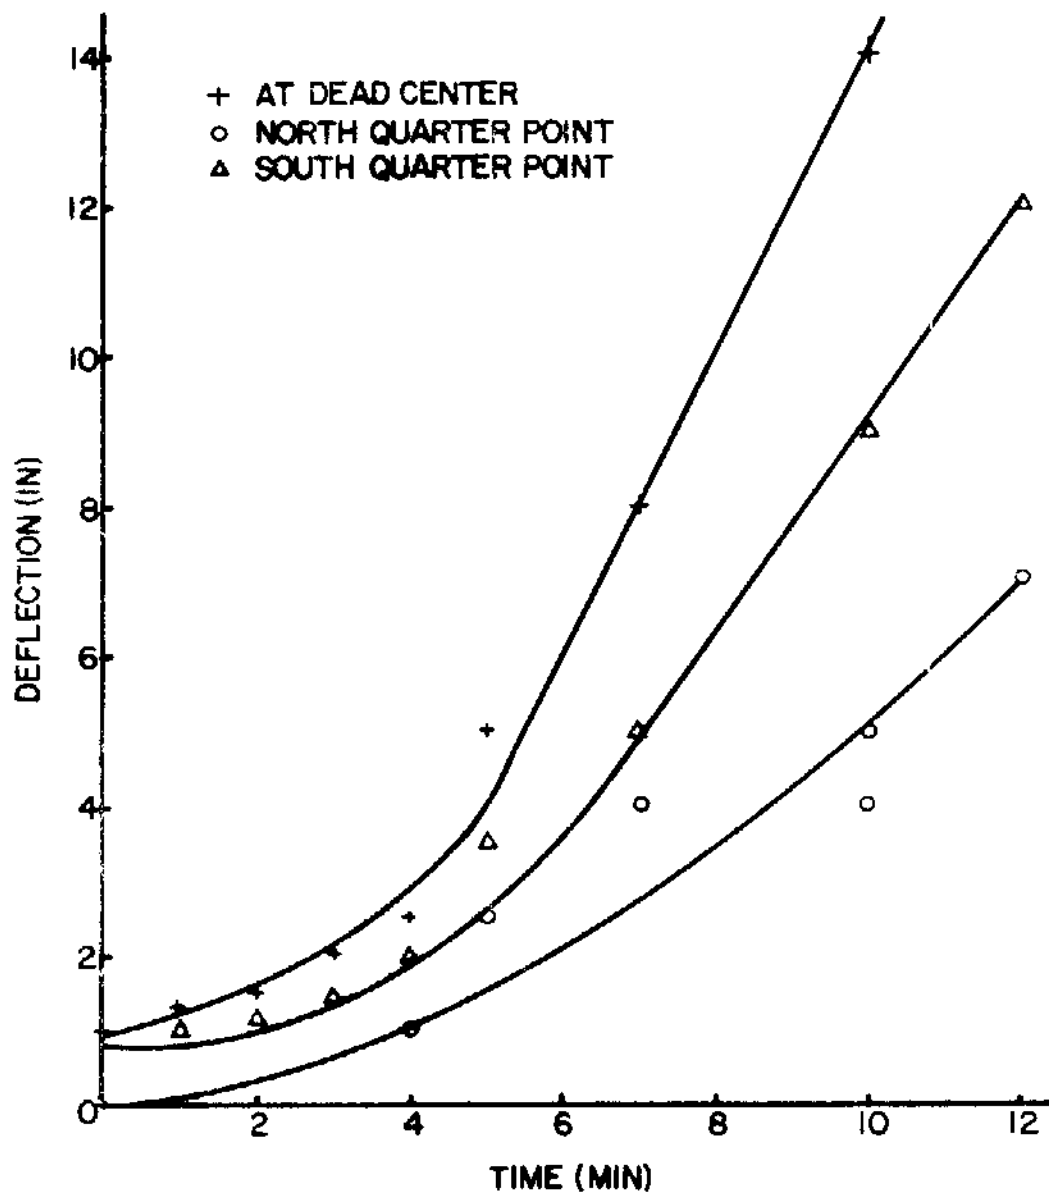
FIGURE 16. Deflection Measurements, Test #L-2

The deflections are tabulated in Table 4, Appendix I and shown graphically in figure 16. The deflection increased rapidly and the floor broke through at 13 min.
